DEPARTMENT OF TRANSPORTATION

Office of Structural Materials

Contract #: 04-0120F4Cty: SF/ALA Rte: 80 PM: 13.2/13.9File #: 69.28**WELDING INSPECTION REPORT****Resident Engineer:**Siegenthaler, Peter**Address:** 333 Burma Road**City:** Oakland, CA 94607**Report No:** WIR-023863**Date Inspected:** 20-May-2011**Project Name:** SAS Superstructure**OSM Arrival Time:** 700**Prime Contractor:** American Bridge/Fluor Enterprises, a JV**OSM Departure Time:** 1900**Contractor:** Zhenhua Port Machinery Company, Ltd (ZPMC), Changxing Island **Location:** Shanghai, China**CWI Name:** Liu Hua Jie.**CWI Present:** Yes No**Inspected CWI report:** Yes No N/A**Rod Oven in Use:** Yes No N/A**Electrode to specification:** Yes No N/A**Weld Procedures Followed:** Yes No N/A**Qualified Welders:** Yes No N/A**Verified Joint Fit-up:** Yes No N/A**Approved Drawings:** Yes No N/A**Approved WPS:** Yes No N/A**Delayed / Cancelled:** Yes No N/A**Bridge No:** 34-0006**Component:** OBG components.**Summary of Items Observed:**

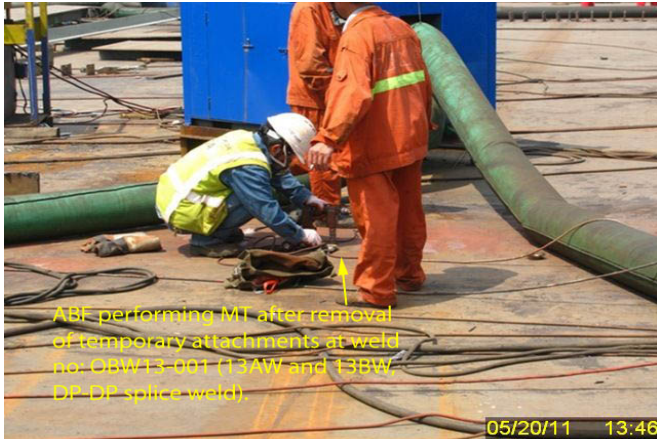
ABF personnel performing Magnetic particle testing (MT) after removal of temporary attachments at weld jt no: OBW13-001 (DP to DP, CJP splice weld). See attached photo for details.
